Maryland Inventory of Historic Properties Historic Bridge Inventory Maryland State Highway Administration Maryland Historical Trust MHT Number AL-II-A-145

Name and SHA No. Dolly Road over Flintstone Creek/A10400 (A10410)
<u>Location:</u> Street/Road Name and Number: <u>Dolly Road</u>
City/Town: Flintstone Vicinity x
County: Allegany
Ownership: _State_x_County_Municipal_Other
This bridge projects over: _Road_Railwayx Water_Land
Is the bridge located within a designated district: yes x no
_NR listed district_NR determined eligible district _locally designated_other Name of District
Bridge Type:
_Timber BridgeBeam Bridge_Truss-Covered_TrestleTimber-and-Concrete
_Stone Arch
_Metal Truss
_Movable BridgeSwingBascule Single Leaf_Bascule Multiple LeafVertical LiftRetractilePontoon
<u>x</u> Metal Girder <u>x</u> Rolled GirderRolled Girder Concrete Encased Plate GirderPlate Girder Concrete Encased

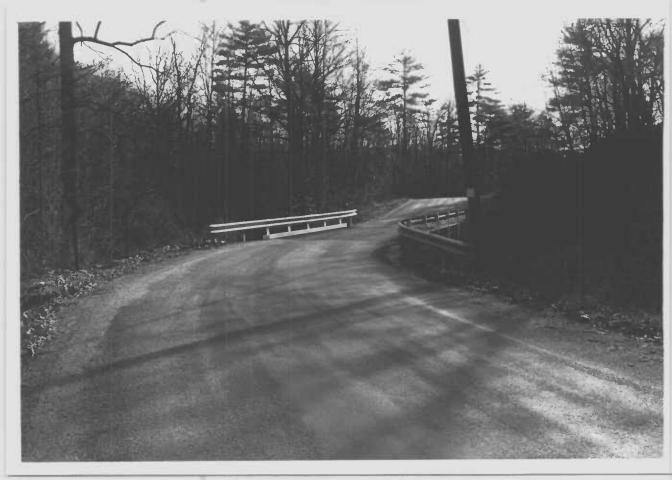
10F4

EAST APPROACH

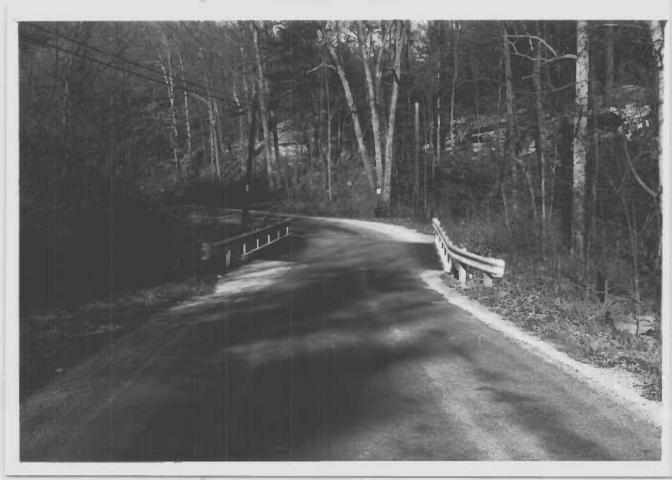
2 OF 4

WEST APPROACH

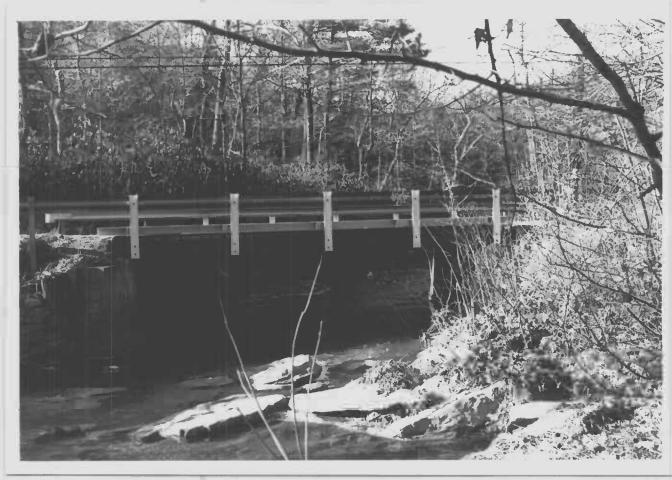
3 OF 4

BR# 20A10410 (A10400) AL-II-A- 145 FLINTSTONE CREEK ALLEGANY CO., MID DAVID KING 2/3/95 S. H.A NORTH ELEVATION (FOUNSTREAM)

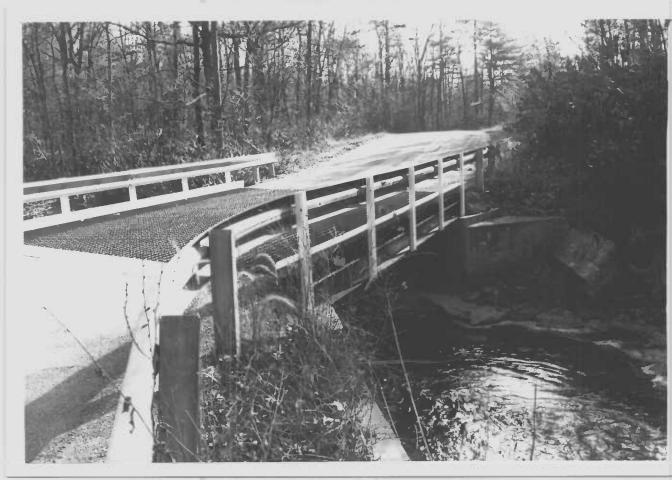
4 OF 4

BR# 20A10410 (A-10400) AL-II- A- 145 FLINTSTONE CREEK ALLEGANY CO., MD DAVID KING 2/3/95 SHA SOUTH ELEVATION (UPSTREAM)
